DESIGN POOR PRACTICE – Clearance around CHW brackets

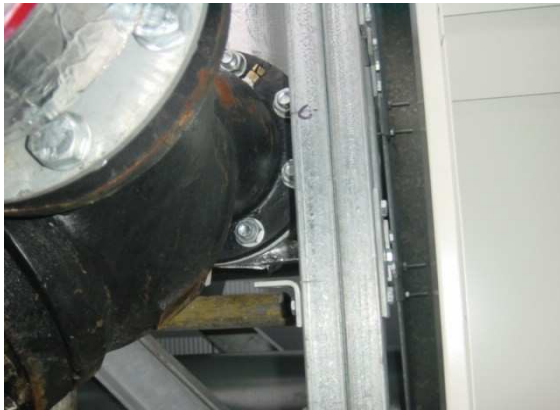
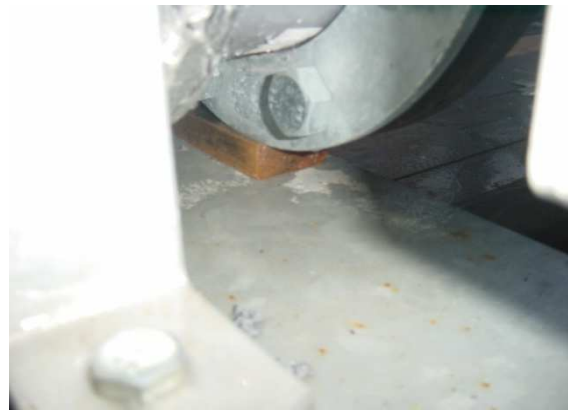
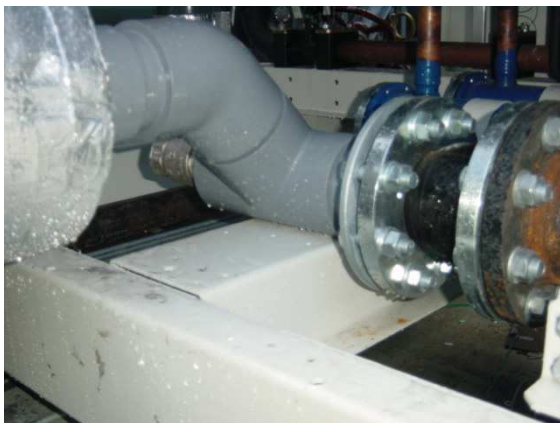
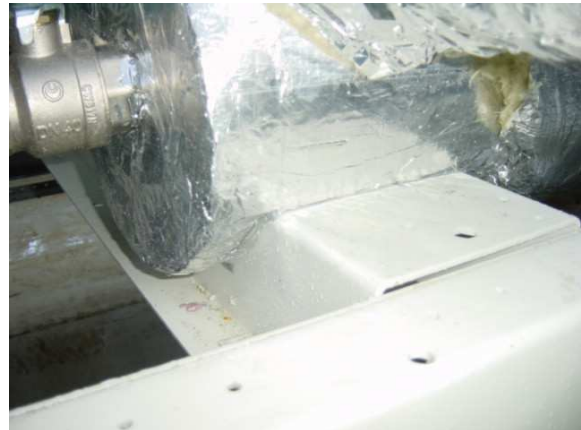
Poor design of the pipework system around brackets and unistrut framework on a Chilled Water system means that clearance for the insulation is insufficient and unless the insulation thickness can be applied to the manufacturers specification, a vapour seal cannot be achieved and the system will continuously cause condensation “sweating” and corrosion.

- However good the workmanship, any attempt to create a vapour seal around the pipework / fitting is futile and a cold bridge forms causing condensation & therefore corrosion will occur.
- The efficiency of the Chiller Unit will be affected (causing energy loss) as the chiller will be over compensating for the lost “cold” around the affected area.
- The cold bridge allows moisture into the vapour-sealed system and can cause extensive corrosion requiring remedial / replacement works.
- If Design Engineers were to liaise with the insulation contractor at early design stage, these issues could be designed out and increase the efficiency of plant and reduce issues on-site which cost time & money.
