Concrete Construction Design - Reducing Health Risks

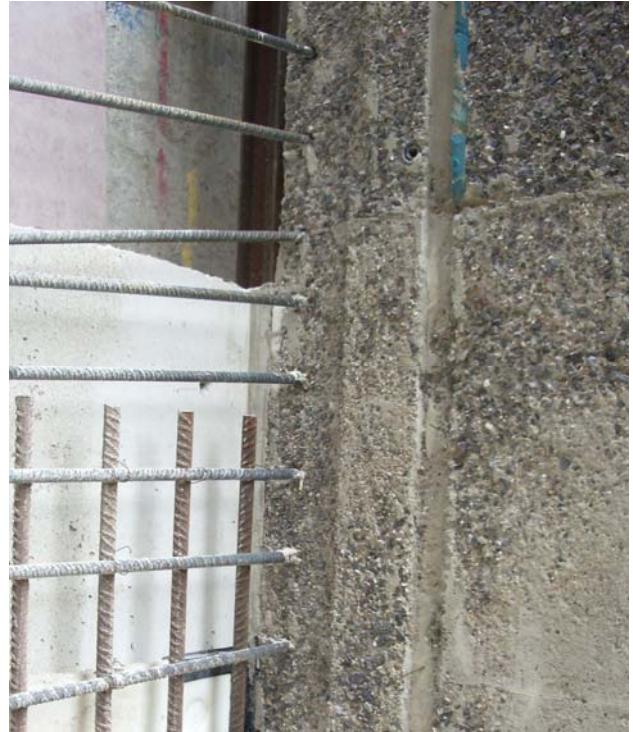
Concrete wall joint after retarder was used and the joint then jet washed

- **Brushing/washing** – the concrete is brushed while still green, and washed to expose the aggregate. Timing is critical.
- **Retarder/washing** – a retarder is applied to the joint surface (horizontal) or the stop end (vertical) to prevent setting of the concrete surface, which is subsequently washed off. There is a risk of getting retarder on surfaces where it is not wanted.
