Access Through Suspended Ceilings

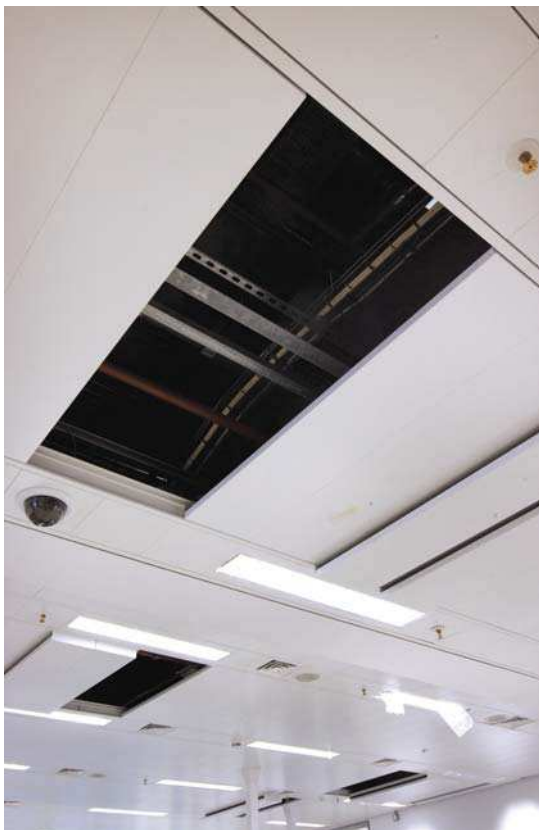
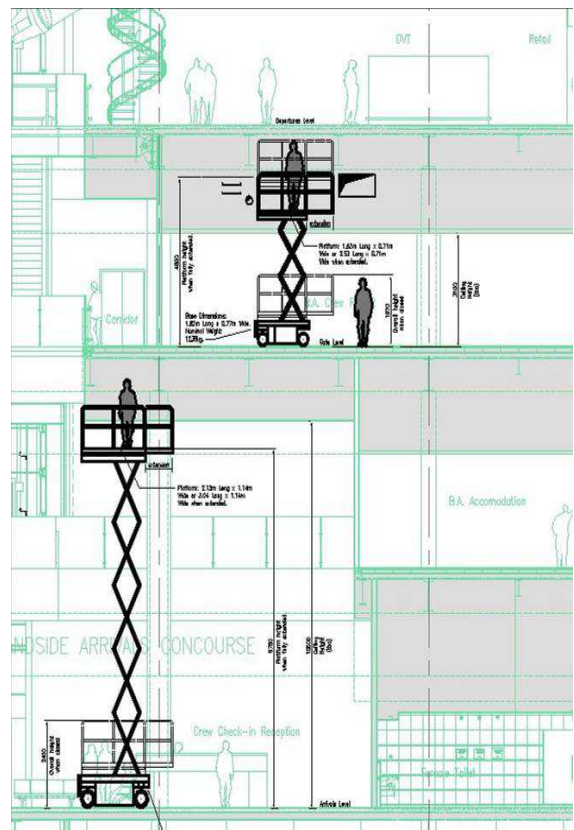
- The selection of 600 x 600 panel size was challenged and large ceiling panels were substituted. These enable access by systems such as mobile elevated work platforms (MEWPs).
- Panels were hinged or had sliding mechanisms so that they could be safely opened.
- The openings in the ceiling and the services running in the voids were designed to provide adequate space for a working platform to be raised between them, giving access to the full height of the void.
- No services were placed in any remaining inaccessible areas.
